# Milan Bath Taps - Pair

MILAN 102

Installation Guide

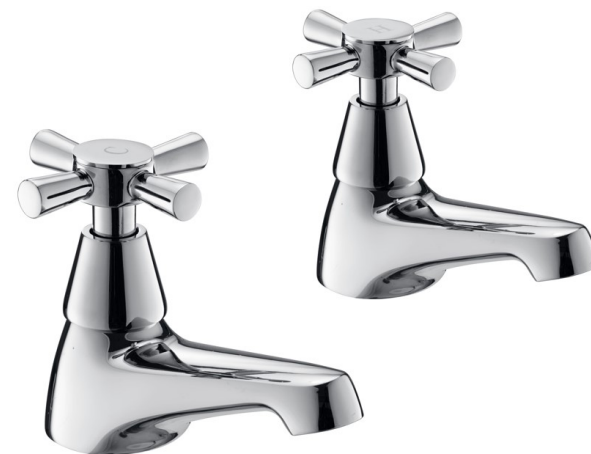
- Suitable for high & low pressure systems
- Non-rising spindle headworks
- Brass Backnuts
- Tap Height 80mm,
- Spout Height 25mm
- Spout Reach 85mm

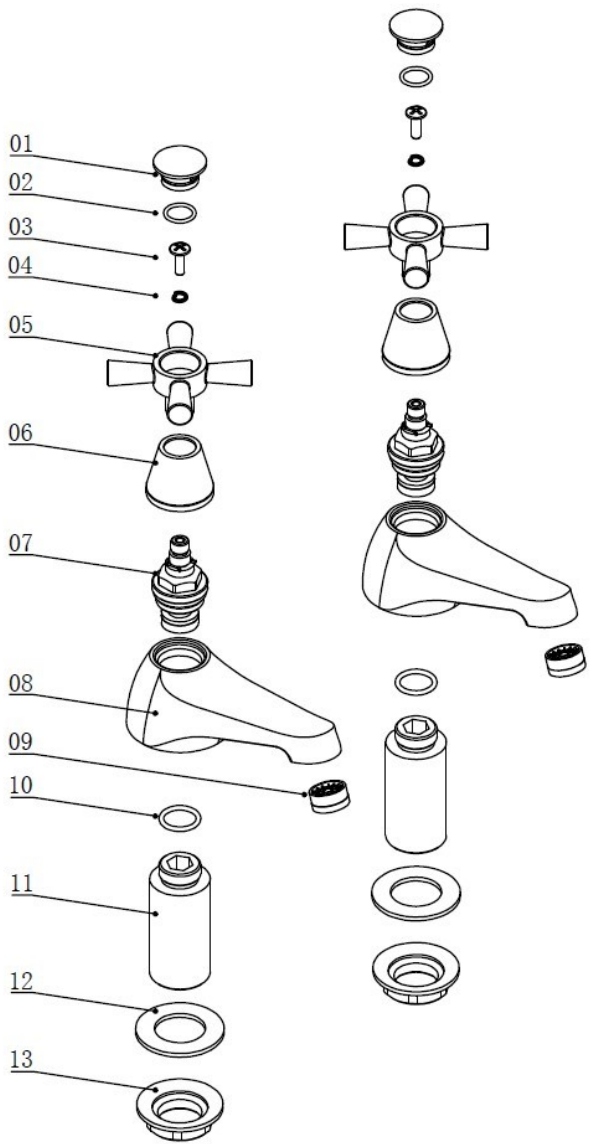
Product Breakdown

Check All components are present prior to starting installation.

| Item Number | Item Description |
| 1 | Hot & Cold Indicators |
| 2 | O-Ring |
| 3 | Screw |
| 4 | Washer |
| 5 | Handle |
| 6 | Cartridge Cover |
| 7 | Non-rising Spindle Headworks |
| 8 | Bath Tap Body |
| 9 | Aerator |
| 10 | O-Ring |
| 11 | ½" BSP Threaded Connection |
| 12 | Washer |
| 13 | Brass Backnuts |

- 1, Remove the metal backnut (13) and washer (12) from the threaded connection (11).
- 2, Place the threaded connection (11) through the hole in the bath and position, so as to direct flow correctly, ensuring the hot tap is positioned on the left hand side and the cold tap is positioned on the right hand side.
- 3, Place washer (12) onto threaded connection (11) between bath unit and backnut (13).
- 4, Tighten the backnut (13) to secure the Bath tap to bath, do not over tighten as this may damage the nut or the unit.
- 5, Before fully tightening, ensure the tap is still positioned correctly.
- 6, Once secured connect the supply pipe and tighten to create a good seal.
- 7, Turn on water supply and check for leaks.
